Impact Angle Effects on Erosion Maps of GFRP: Applications to Tidal Turbines

Rafee Abdulmajeed Rafee Ahamed¹ · Cameron M. Johnstone¹ · Margaret M. Stack¹

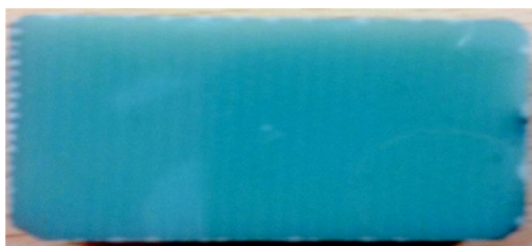
Fig. 2 Rectangular specimen (36 mm × 25 mm × 6 mm)

A schematic diagram of the slurry impingement jet rig is shown in Fig. 1. The rig is equipped with a 'T'-shaped ejector, and it controls the erosion parameters by setting up the ratio of inlet nozzle to the outlet nozzle diameter (d/D), and the L-distance [9]. The erosion test was performed at three different impact velocities of 2.5 , 4.5 and 6.5 ms^{-1} , and the corresponding combinations of inlet and outlet nozzles are 2.8 and 6.52 mm (2.5 ms^{-1}), 3.6 and 6 mm (4.5 ms^{-1}), and 3.6 and 4.48 mm (6.5 ms^{-1}). The impingement angle was adjusted in the range of 15° – 90° . The slurry mixture consists of 3.5% of the salt and 3% of irregular silica sand as an erodent (Table 2). The silica sand particles were supplied by the Fife Silica Sands Ltd. The samples were tested one at a time by fixing onto the specimen holder and eroding for 30 min (Fig. 2).
